City of Maple Ridge

CONSERVATION PLAN

DECEMBER 2015

DONALD LUXTON
AND ASSOCIATES INC

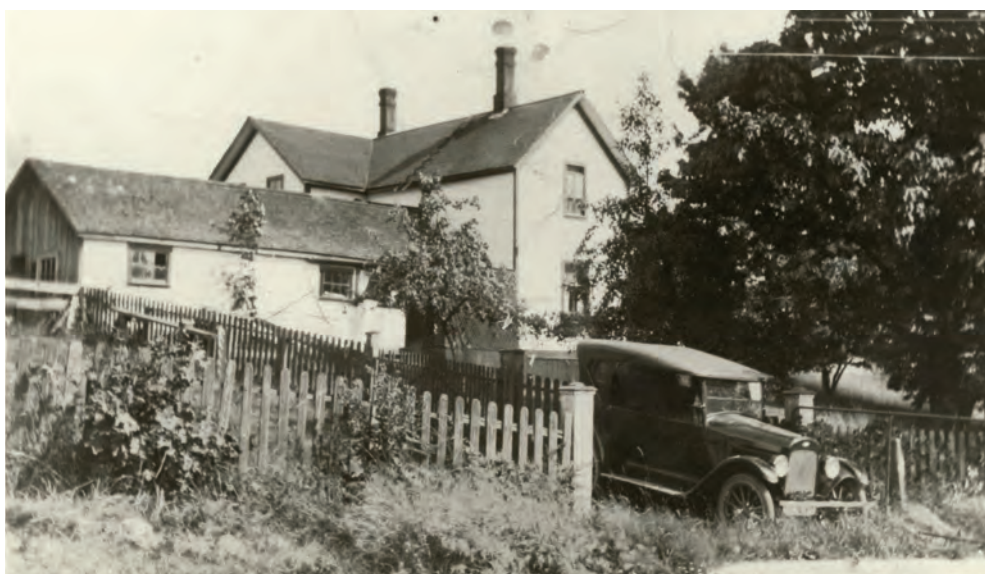
Photograph of the Haney House showing woodshed, stable, and addition to the north side of the house. Taken facing east from Ontario Street. [MRM&CA P00323]

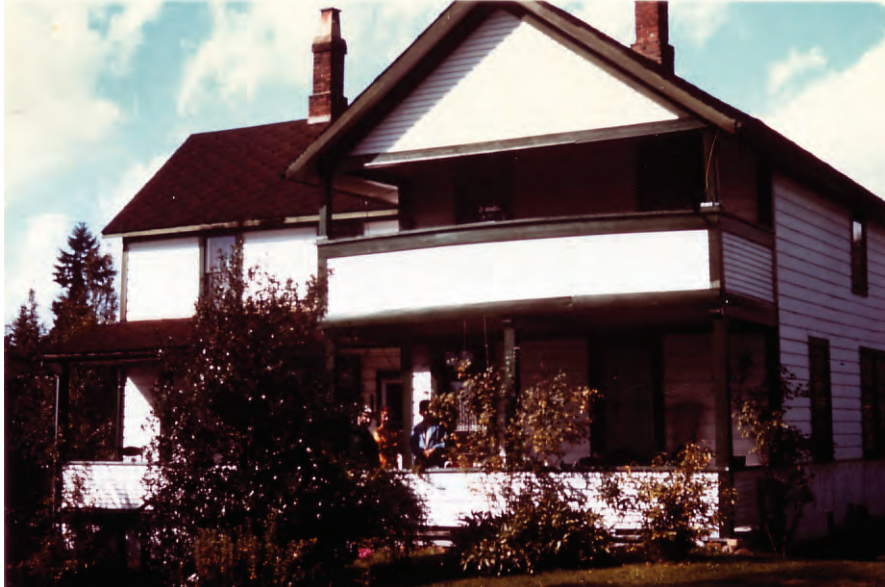
Haney House with solid filled in balcony and porch edgings - no spindles [MRM&CA P08858]

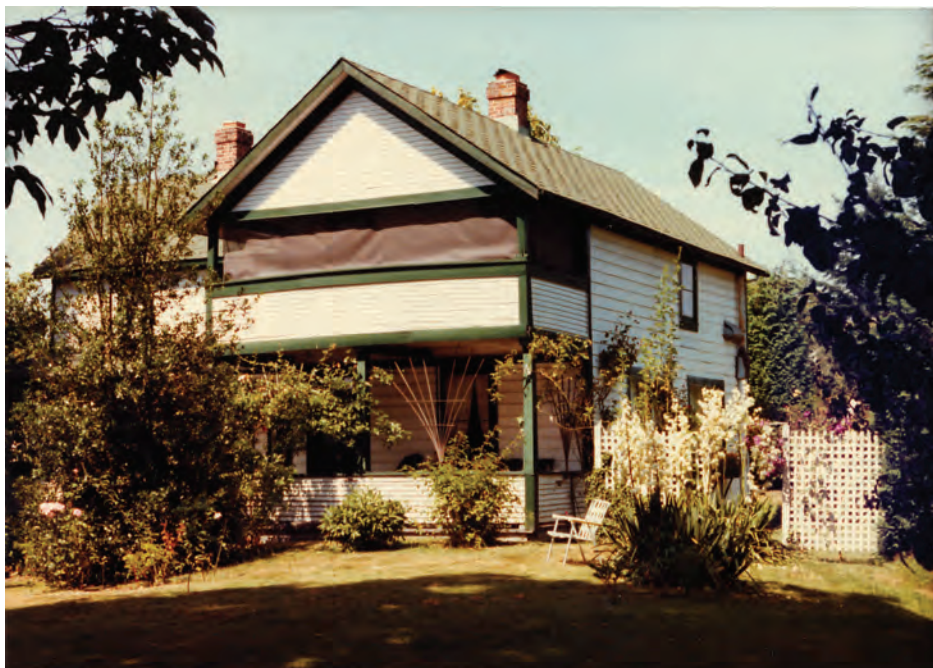
View of Haney House when porches were solid sided. Upper balcony is roofed and screened in. [MRM&CA P08903]

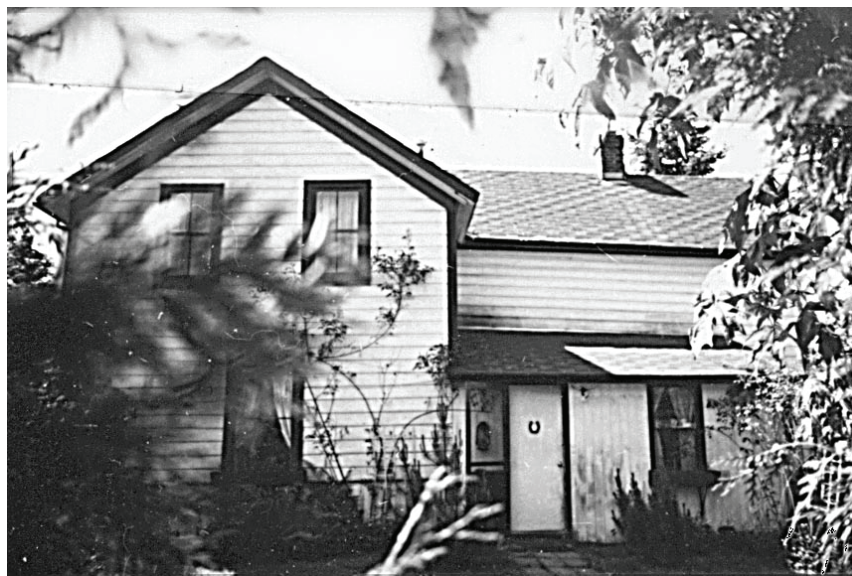
North side of the Haney House showing the building before the dairy was re-built. A small lean-to addition at the back door. [MRM&CA P06922]

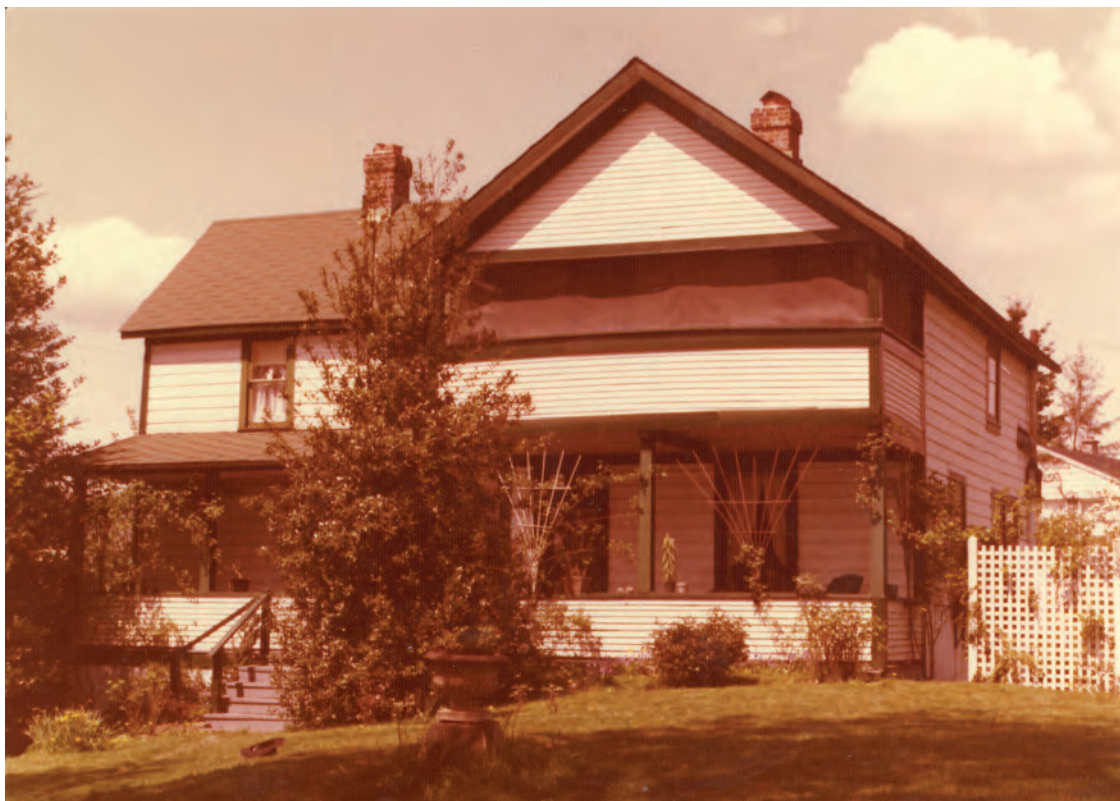
The south side of Haney House. Upper floor shows closed in porch. [MRM&CA P00422]

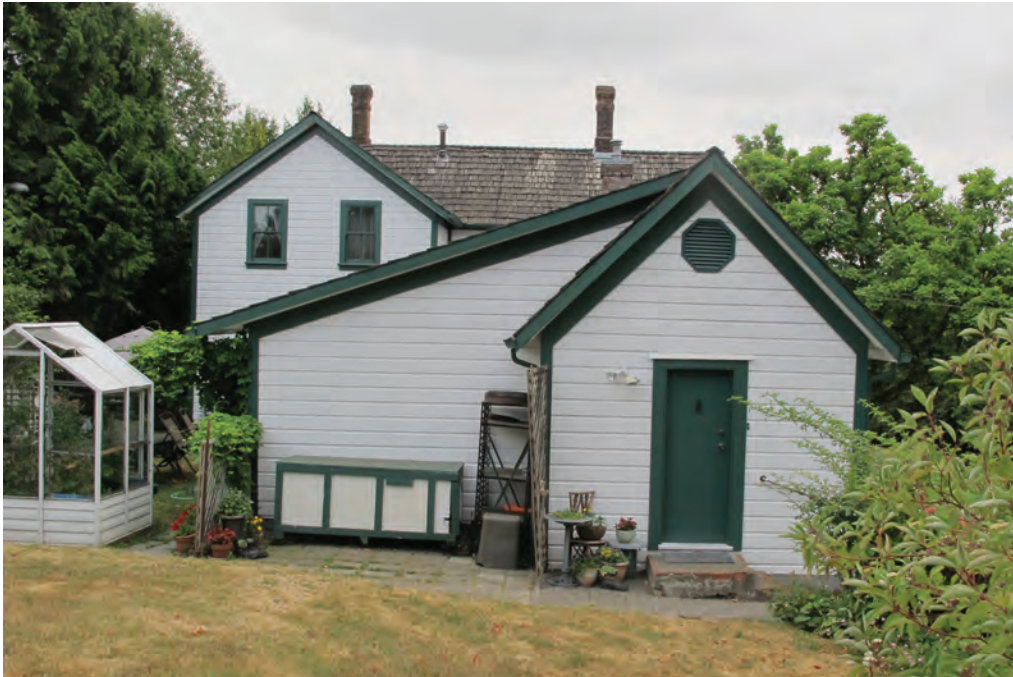
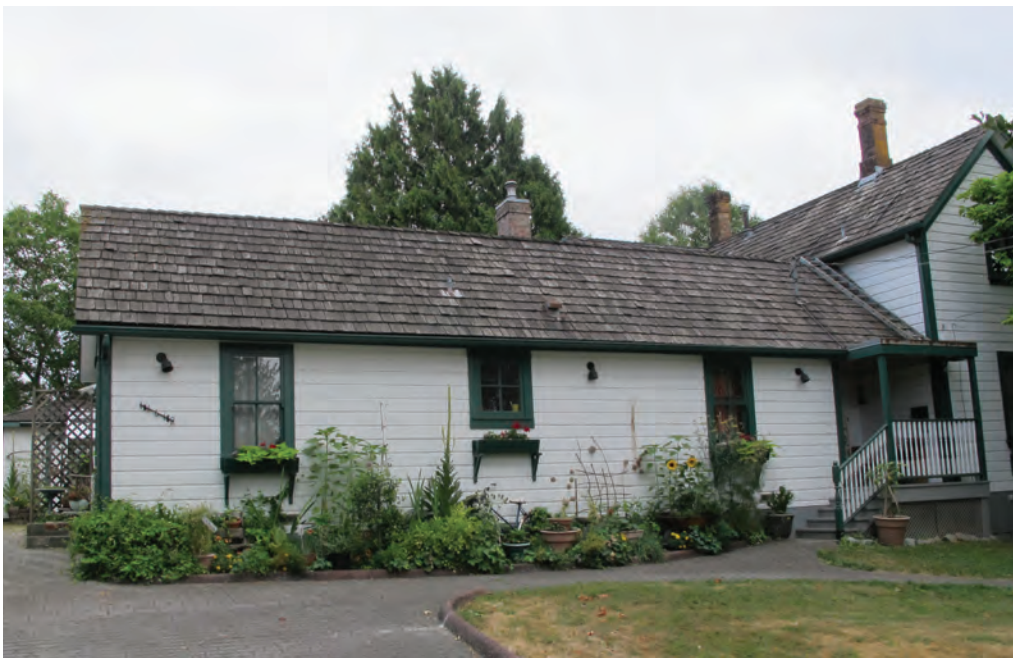
Top: Rear view of Haney House with addition
Bottom: Rear addition

- A qualified Structural Engineer should review the foundations to ensure that they are suitable, including but not limited to a structural and seismic review. This review should include the anchoring of the house to the foundation.

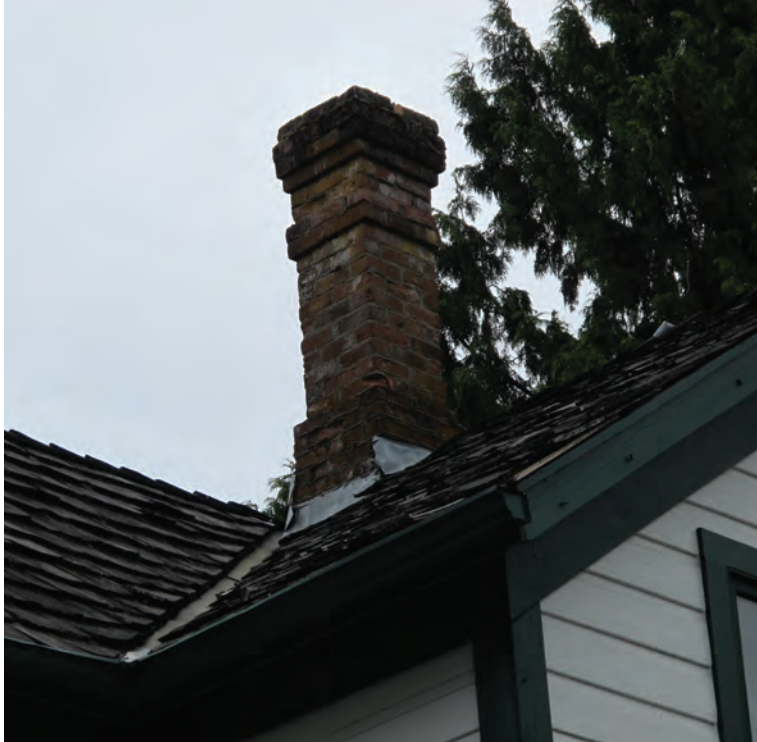
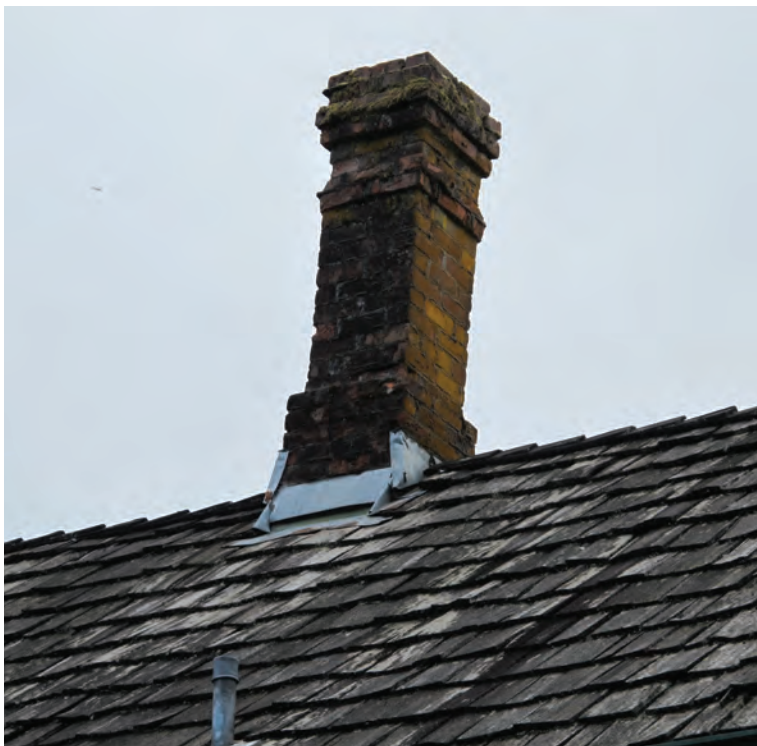
Haney House chimneys

- Clean the rebuilt internal unpainted brick chimneys using the gentlest means possible, and without chemicals (see Section 6.3 for more detail).
- Undertake repairs to the bricks only as necessary, and utilizing the principle of minimum intervention. Use an appropriate restoration mortar for small areas of brick damage or deterioration. For larger areas of damage where whole bricks need to be removed, replace with new brick(s) that match the existing in appearance and performance.
- Repoint only as necessary, and with a mortar that matches the original in colour, material and strength. Repairs should match the original mortar joint profile.
- The existing flashing on both chimneys should be replaced with new flashing in a neutral colour that does not stand out from the roof.

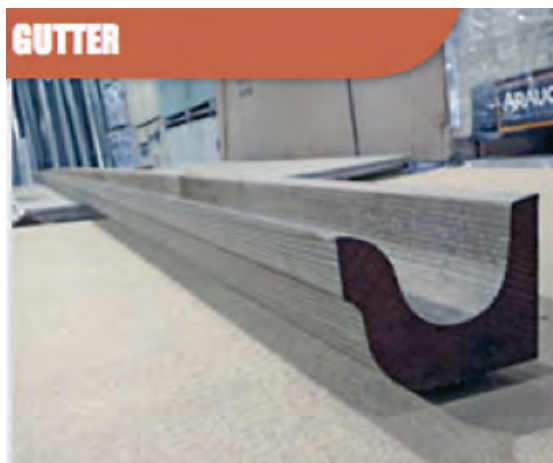
Profile of wooden gutter from Standard Building Supplies

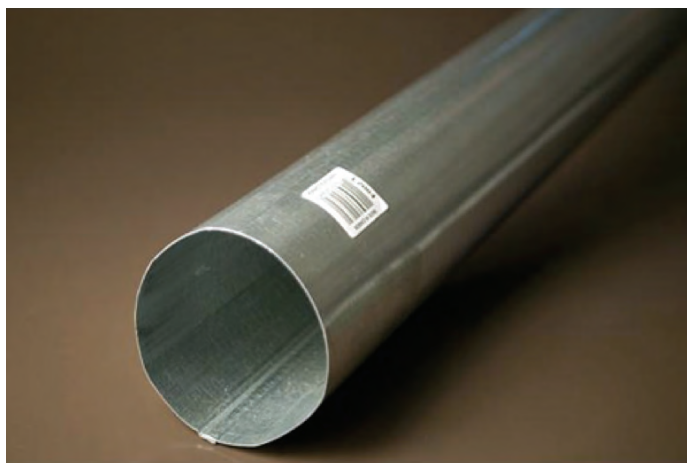
Round galvanized downspout from City Sheet Metal Co. Ltd.

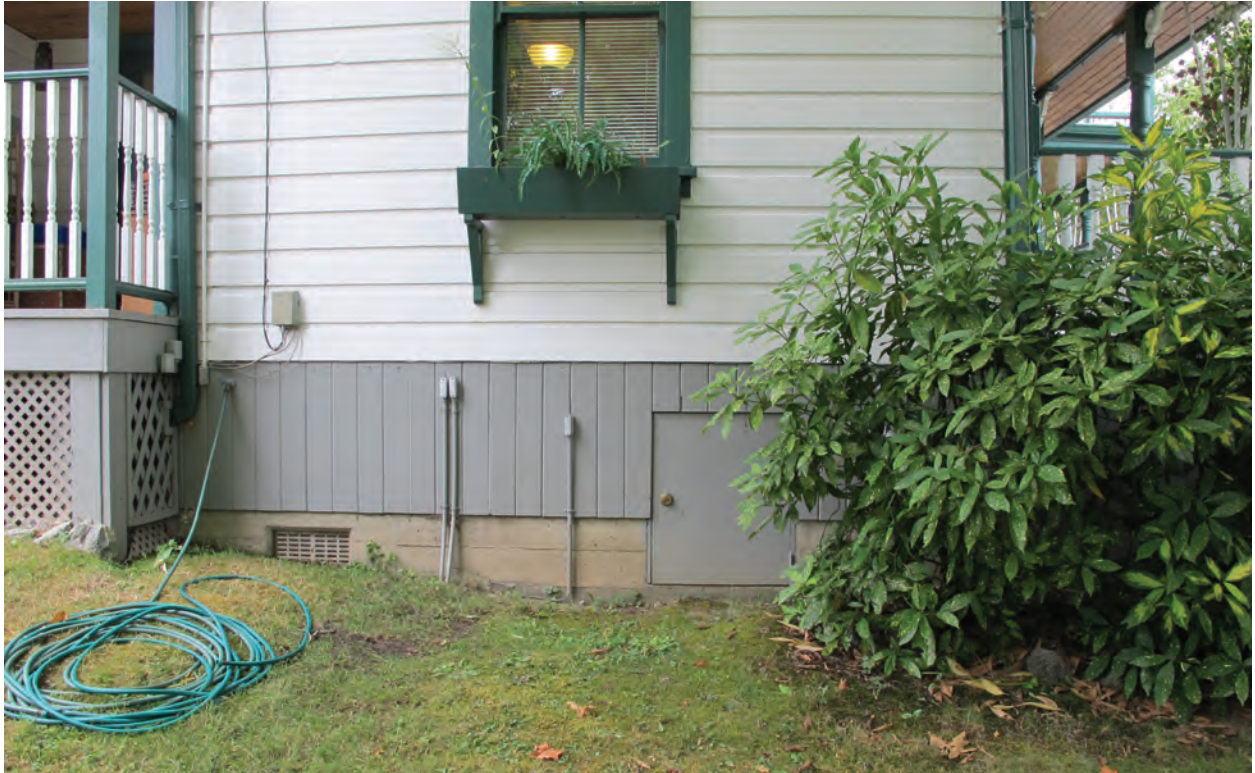
Vertical tongue-and-groove cladding and exposed poured-in-place concrete foundation below

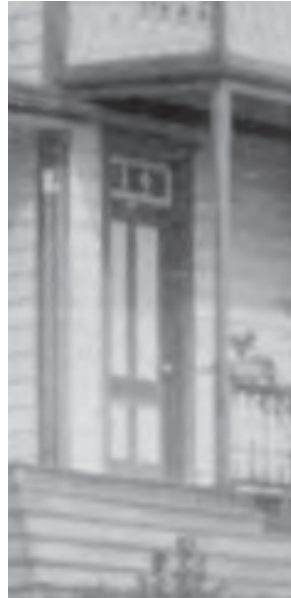
Archival image of door at D102

- Restore the original front doors based on archival evidence.
- The later wood storm door may be replaced with a wood storm door based on the first documented storm door in that location.
- The later rear doors located on the north wing should be replaced with new wood doors that are appropriate to the historic character of the house.
- All restored doors to have appropriate hinges and hardware.

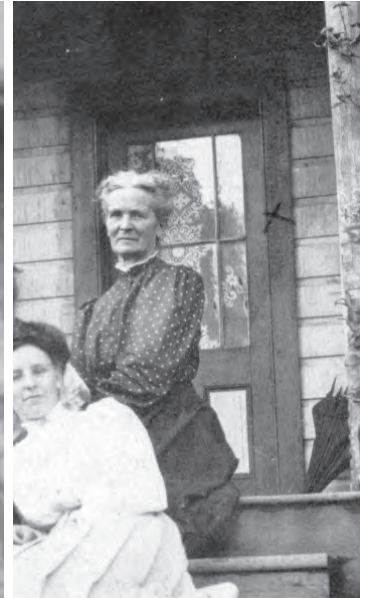
Archival image of door at D101

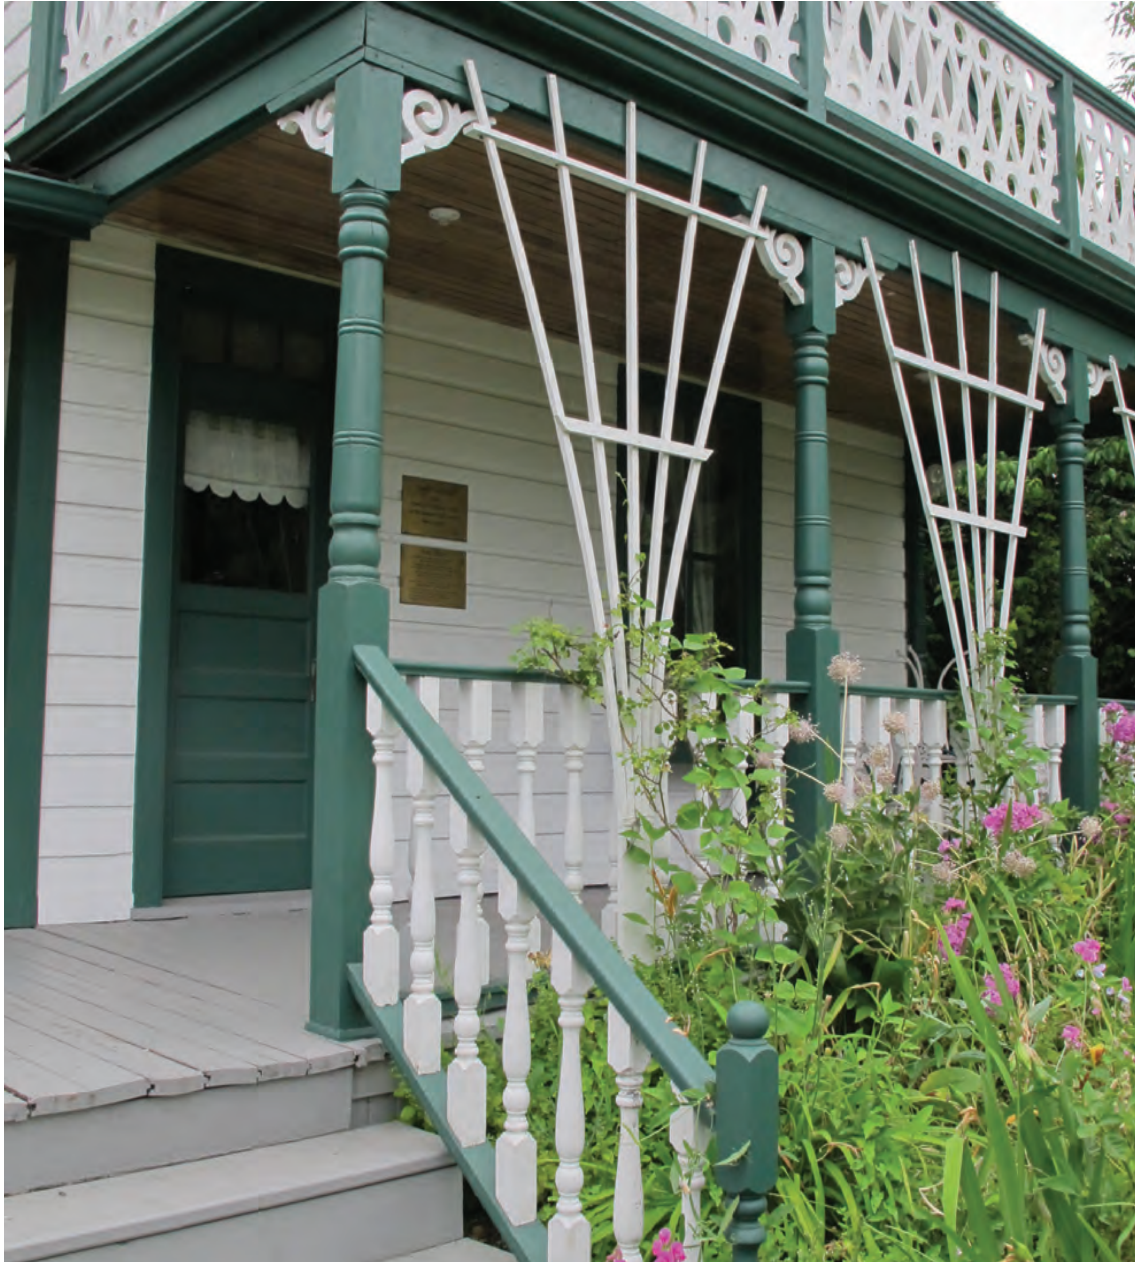
Existing front verandah door

- Restore the front verandah to its original detailing.
- Replace the balustrade, columns and scroll cut brackets based on archival evidence. The Heritage Consultant should review shop drawings prior for these elements.
- Reinstate appropriate tongue-and-groove wood decking and soffit.
- Paint all porch elements, including the soffit, according to the colour schedule devised by the Heritage Consultant.

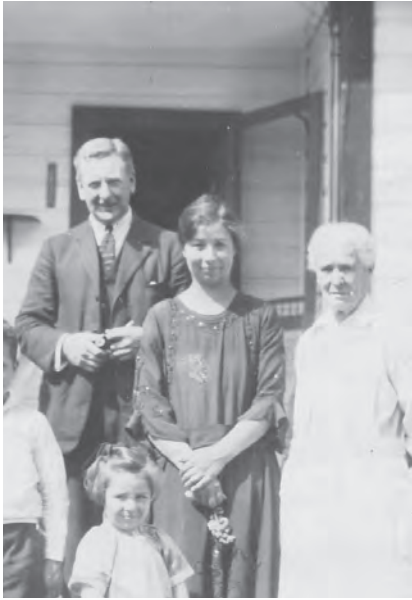
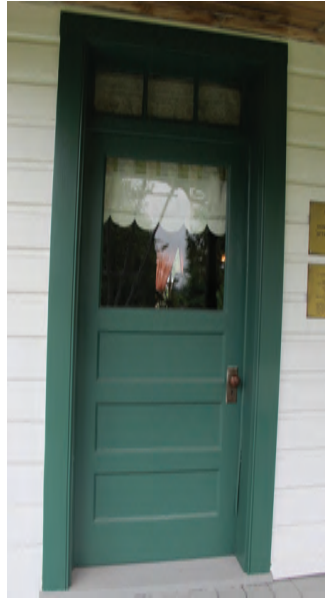
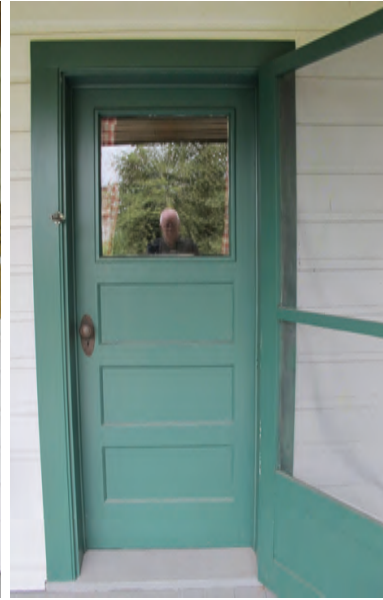
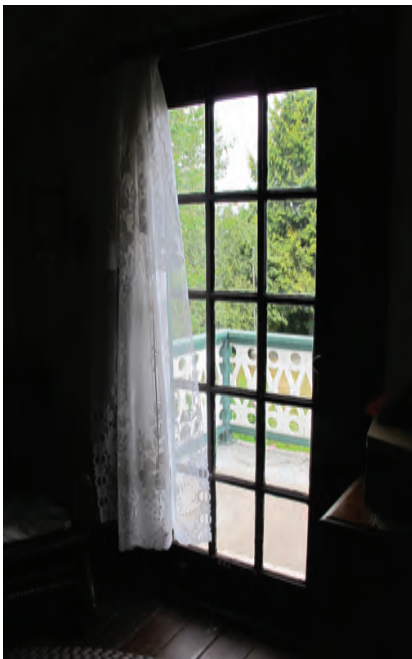
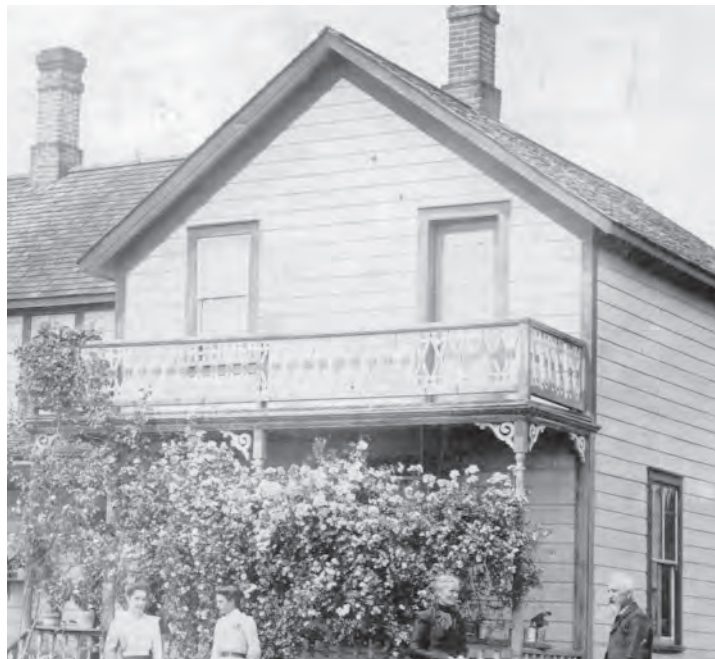
Clockwise from top left: a) Early wood storm door at D101; b) Existing door with original transom at D102; c) Existing door at D101 with existing storm door; d) Existing door at D201; e) Archival image of door at D201

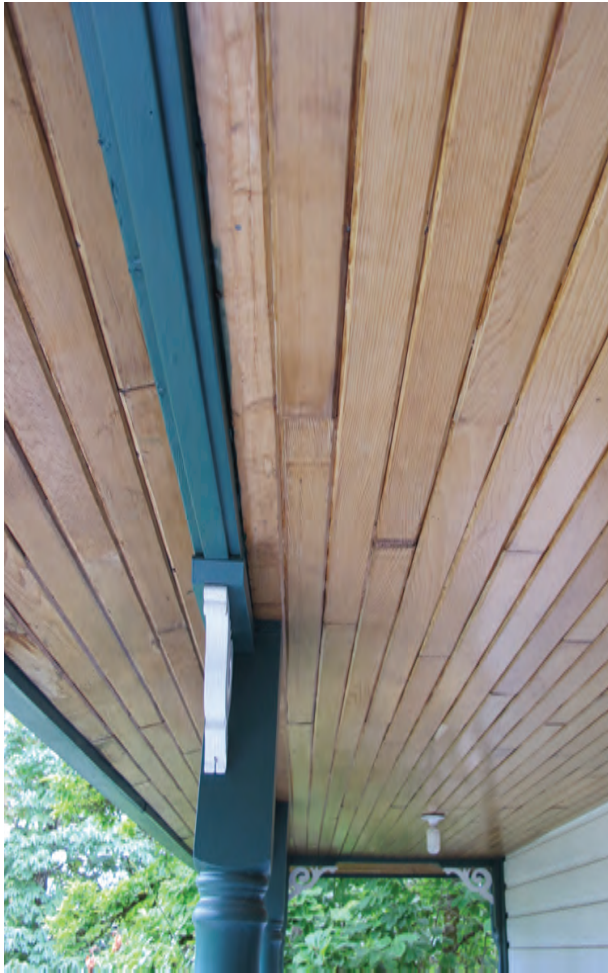
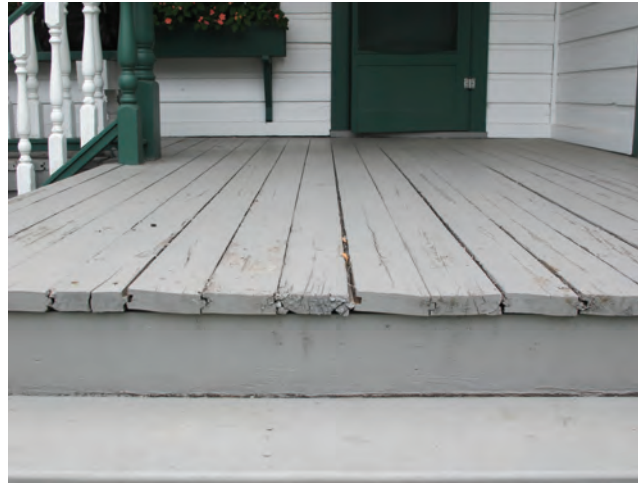
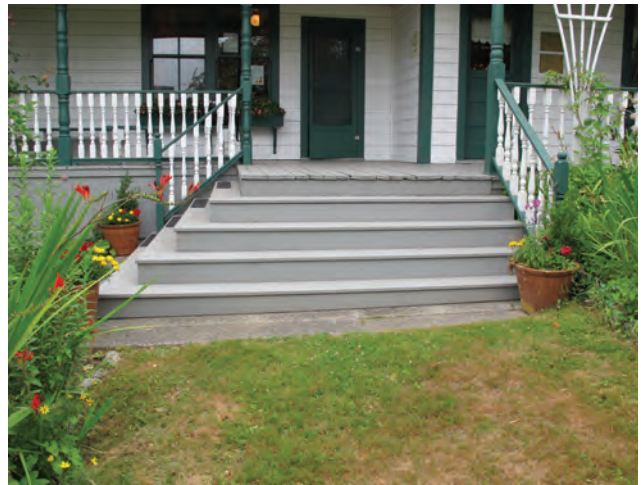
Clockwise from top left: a) inaccurately unpainted wood soffit; b) existing tongue-and-groove decking; c) existing front verandah stairs

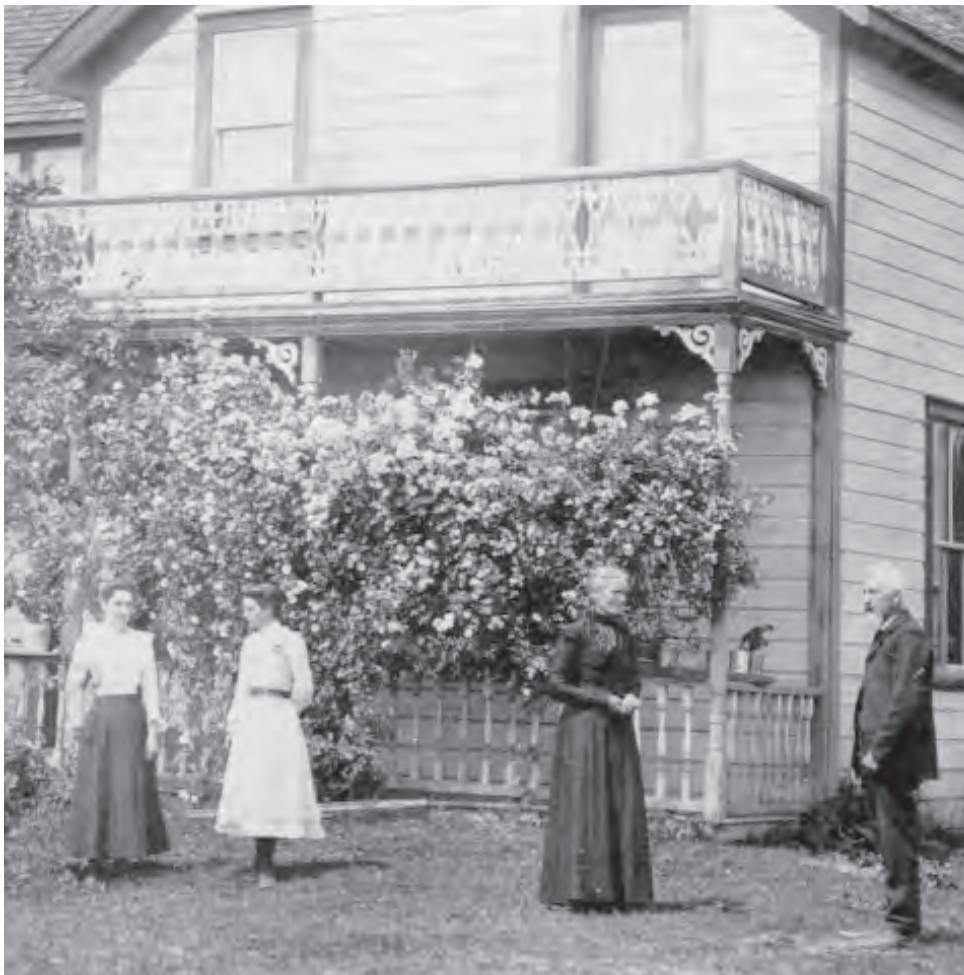
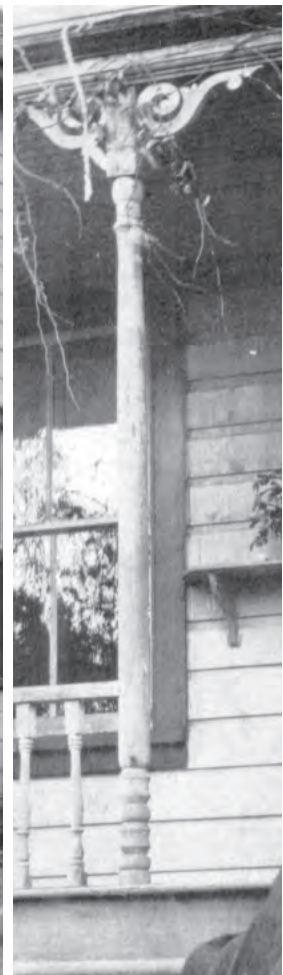
Archival images showing the earliest recorded appearance of the front verandah and balcony. Note the difference in balustrade height and details, as well as the column profile and colours.

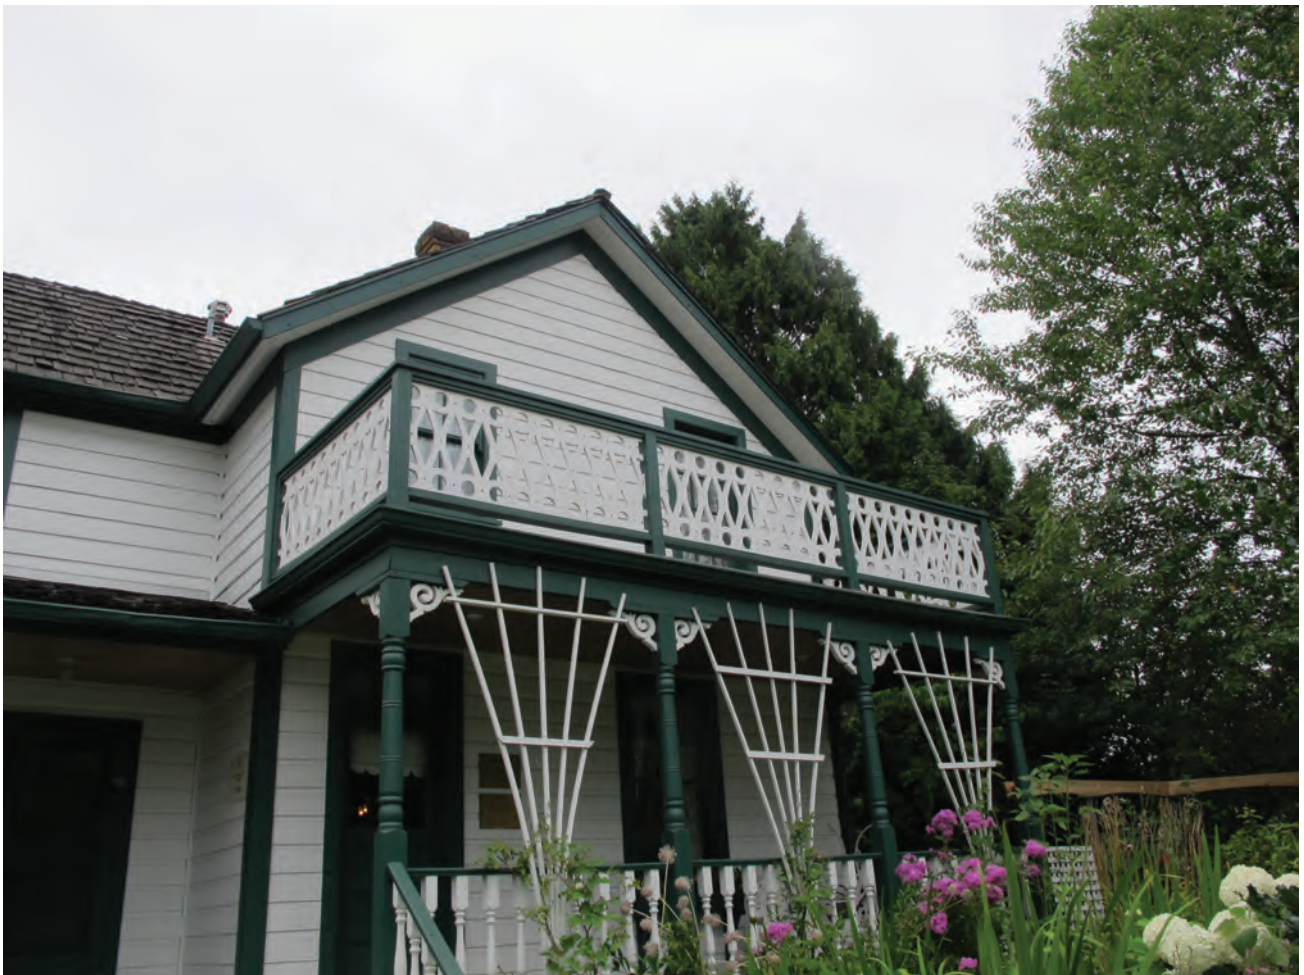
Existing front verandah and balcony

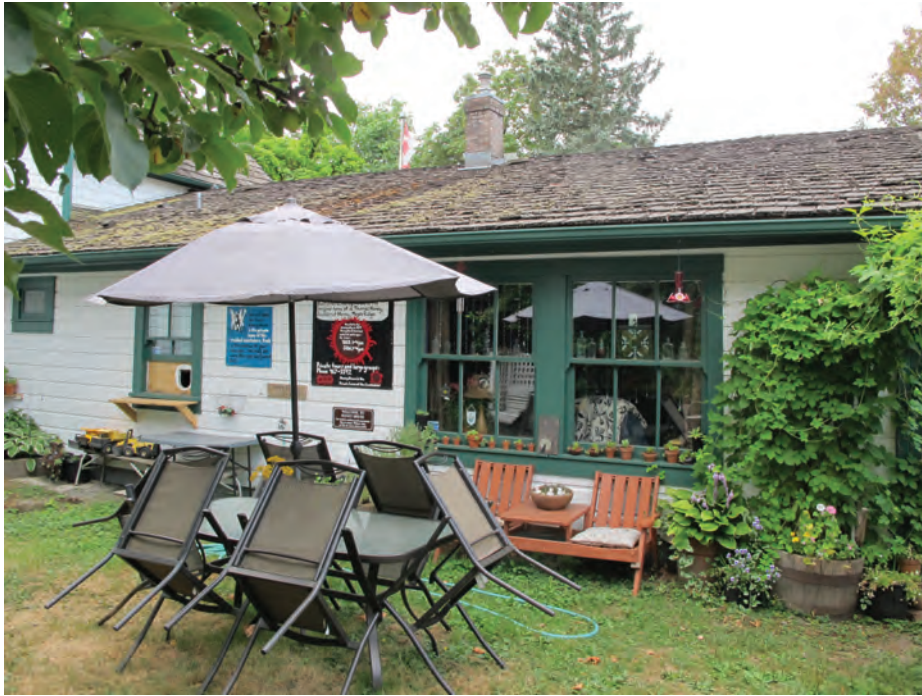
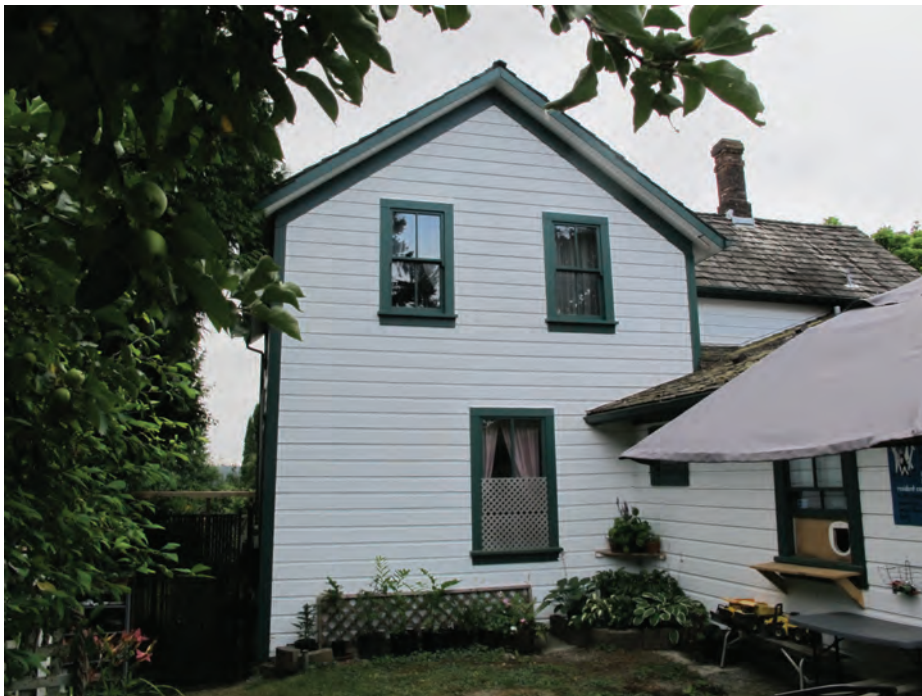
Top: Later rear addition
Bottom: Original rear massing

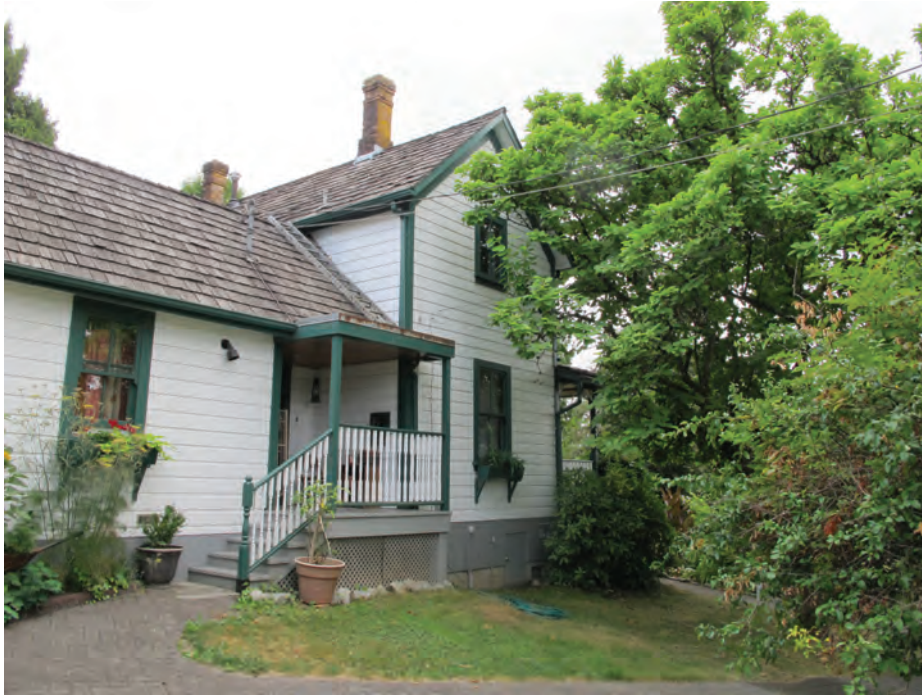
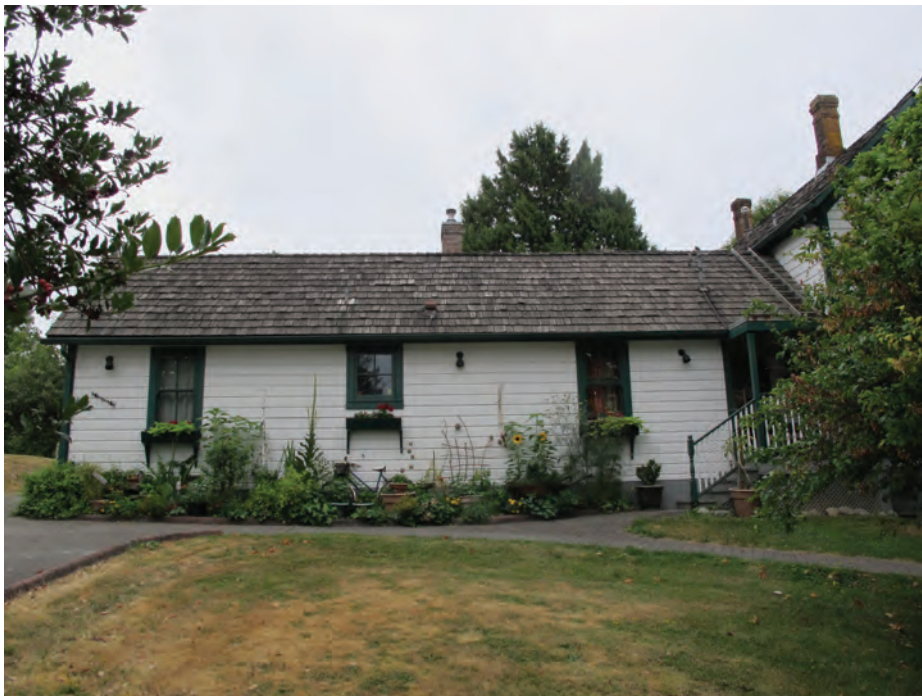
The later side entry verandah has been replaced almost entirely, and there is no documentation of its original configuration.

Top: Side entry porch
Bottom: Side view of rear addition

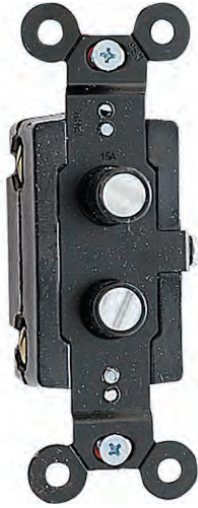
Push-button switch from Rejuvenation

- Replace all contemporary and later light switches and plates with historically appropriate push-button switches and coverings. An acceptable product would be the single pole or 3-way switch from Rejuvenation [<http://www.rejuvenation.com/>] with oil-rubbed bronze switchplates.

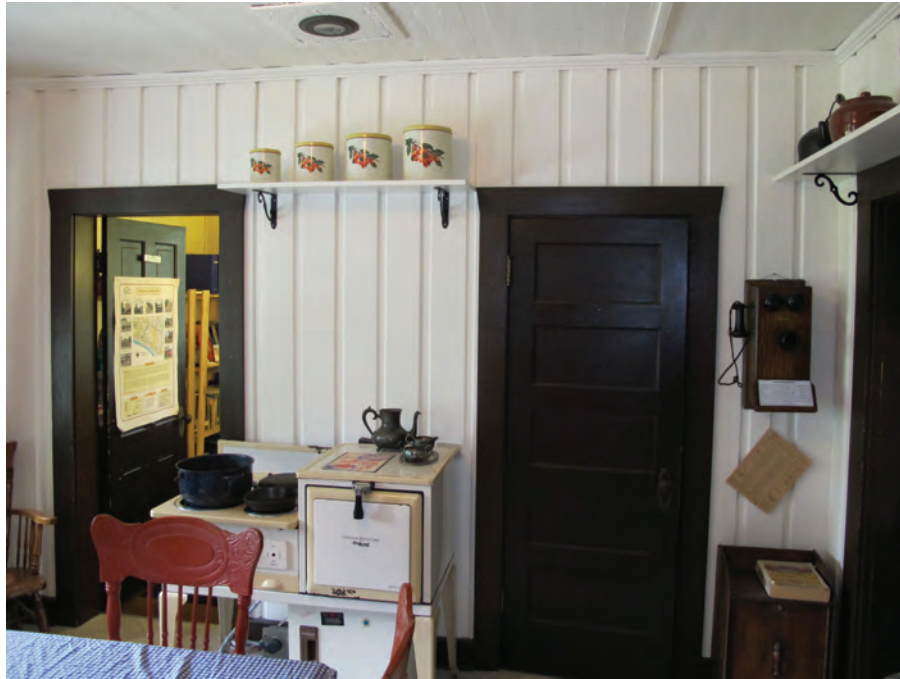
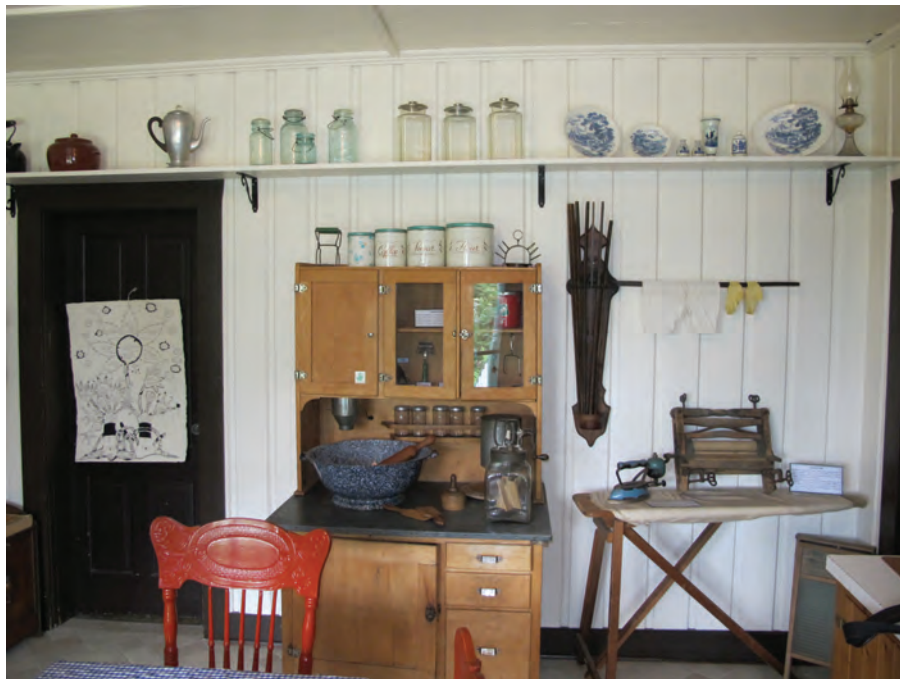
This is the most altered room in the house. Because the Hawley family lived here until 1979, new technologies were continually brought in here, more than anywhere else in the house. What still exists has largely been donated, and represents a mixture of a century of kitchen technology. There are some butter churns on display, as well as a butter mold made of wood with an oak leaf design. This mold belonged to Anne Haney and was for the butter to cool in after it was churned.

Interior of kitchen

- Restore the kitchen to a decided restoration era.
- Preserve and restore original wood elements based on the recommendations in Section 6.1.1.
- Preserve the bullet holes in the ceiling.
- Preserve any original furnishings in the room, and continue to display the kitchen with appropriate artifacts and as an accurate example of the restoration era.

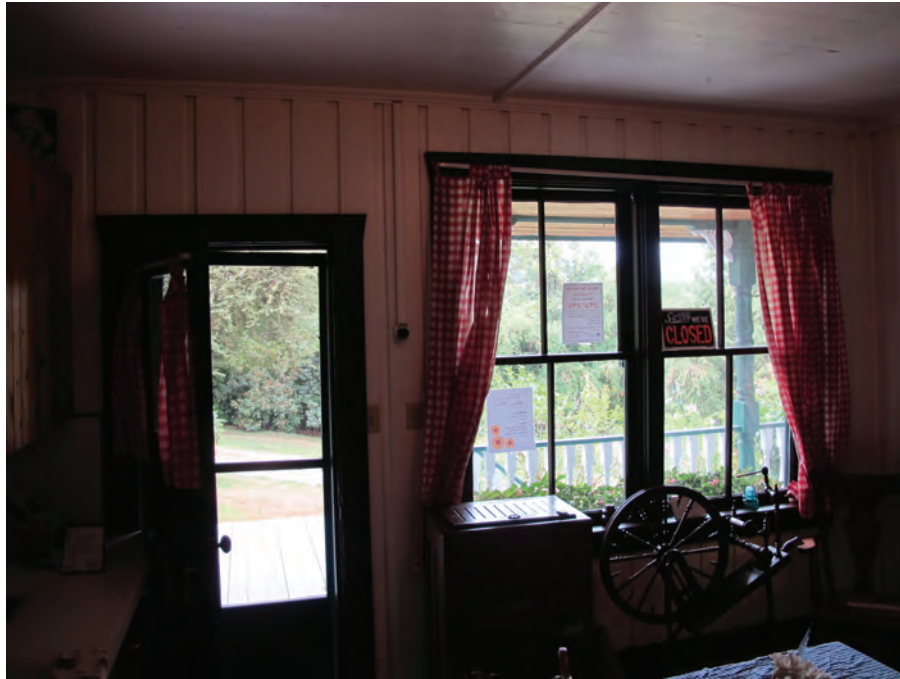
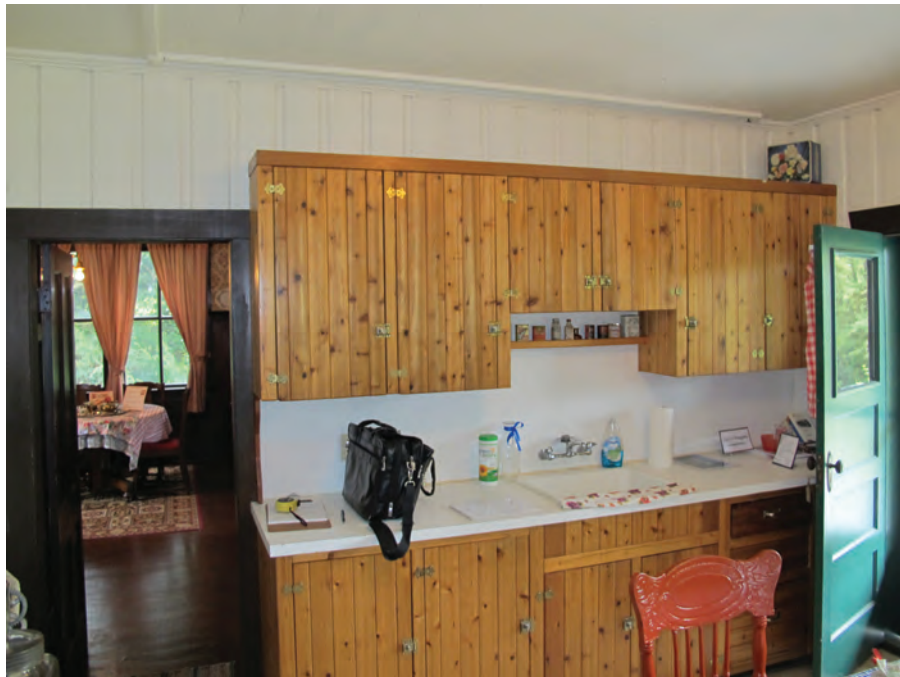
Interior kitchen

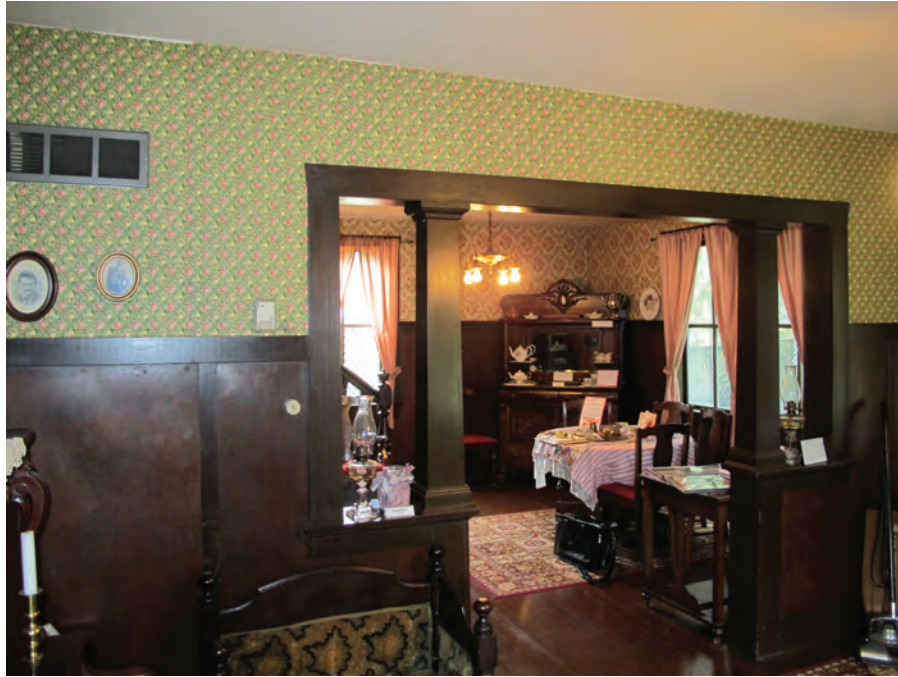
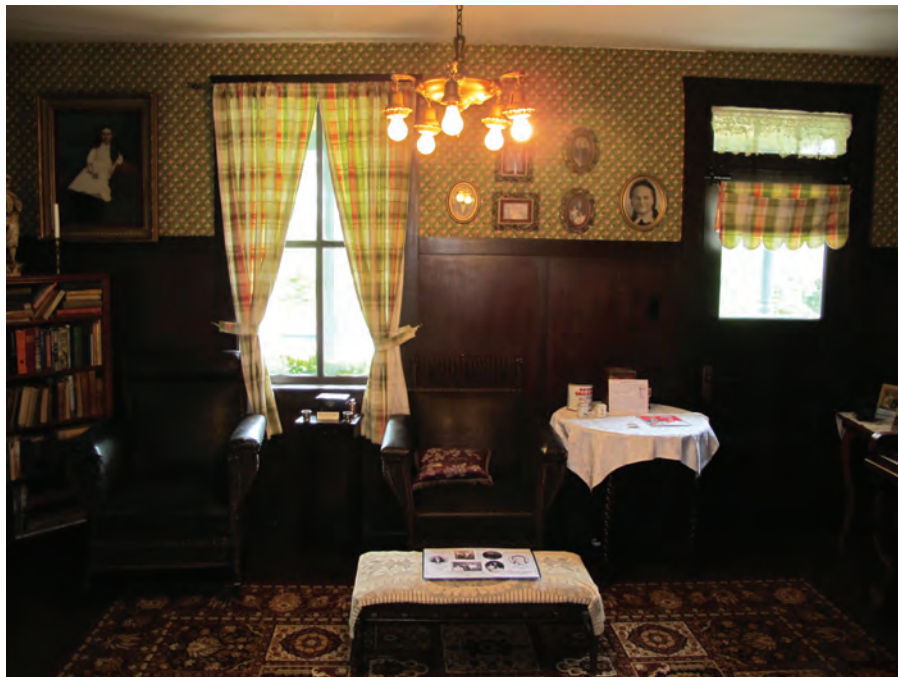
The wood wainscot panelling is of cottonwood, 64" high and up to 32" wide with battens covering the joints, and was imported from Washington State. Today cottonwood is only used for pulp and paper. It is believed that it was added to the house post 1911. The angled top trim of the door and window openings would have been more typical of this period than the original construction of the house. The wallpaper above was added in the 1979-80 renovations.

Interior of Parlour

- Restore the parlour to a decided restoration era.
- Preserve and restore original wood elements based on the recommendations in Section 6.1.1.
- Preserve any original furnishings in the parlour, and continue to display the room with appropriate artifacts and as an accurate example of the restoration era.
- The existing wallpaper is not appropriate to the historic character of the house, and should be replaced with another, appropriate wallpaper.
