City of Maple Ridge

CONSERVATION PLAN

DECEMBER 2015

DONALD LUXTON
AND ASSOCIATES INC

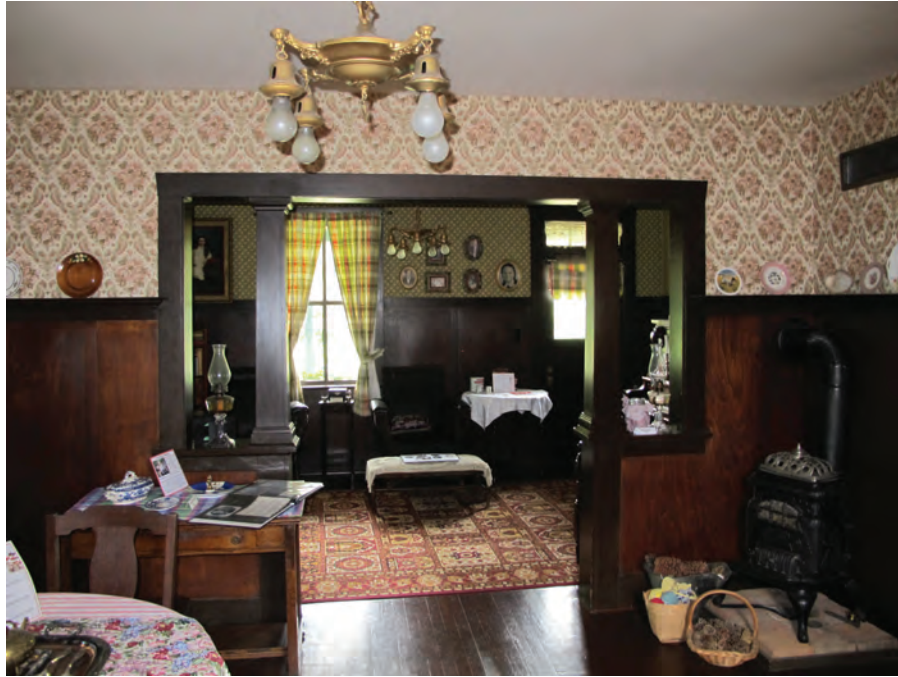
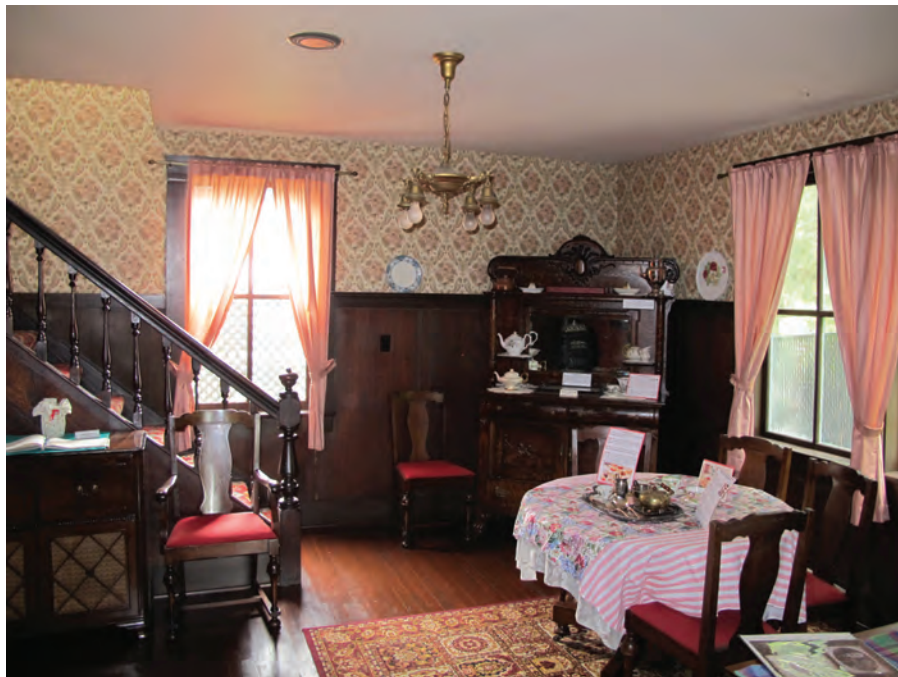
The wood wainscot panelling is of cottonwood, 64" high and up to 32" wide with battens covering the joints and a plate rail above, and was imported from Washington State. Today cottonwood is only used for pulp and paper. It is believed that it was added to the house post 1911. The angled top trim of the door and window openings would have been more typical of this period than the original construction of the house. The wallpaper above was added in the 1979-80 renovations.

Interior of Dining Room

- Restore the dining room to a decided restoration era.
- Preserve and restore original wood elements based on the recommendations in Section 6.1.1.
- Preserve any original furnishings in the room, and continue to display the dining room with appropriate artifacts and as an accurate example of the restoration era.
- The existing wallpaper is not appropriate to the historic character of the house, and should be replaced with another, appropriate wallpaper.

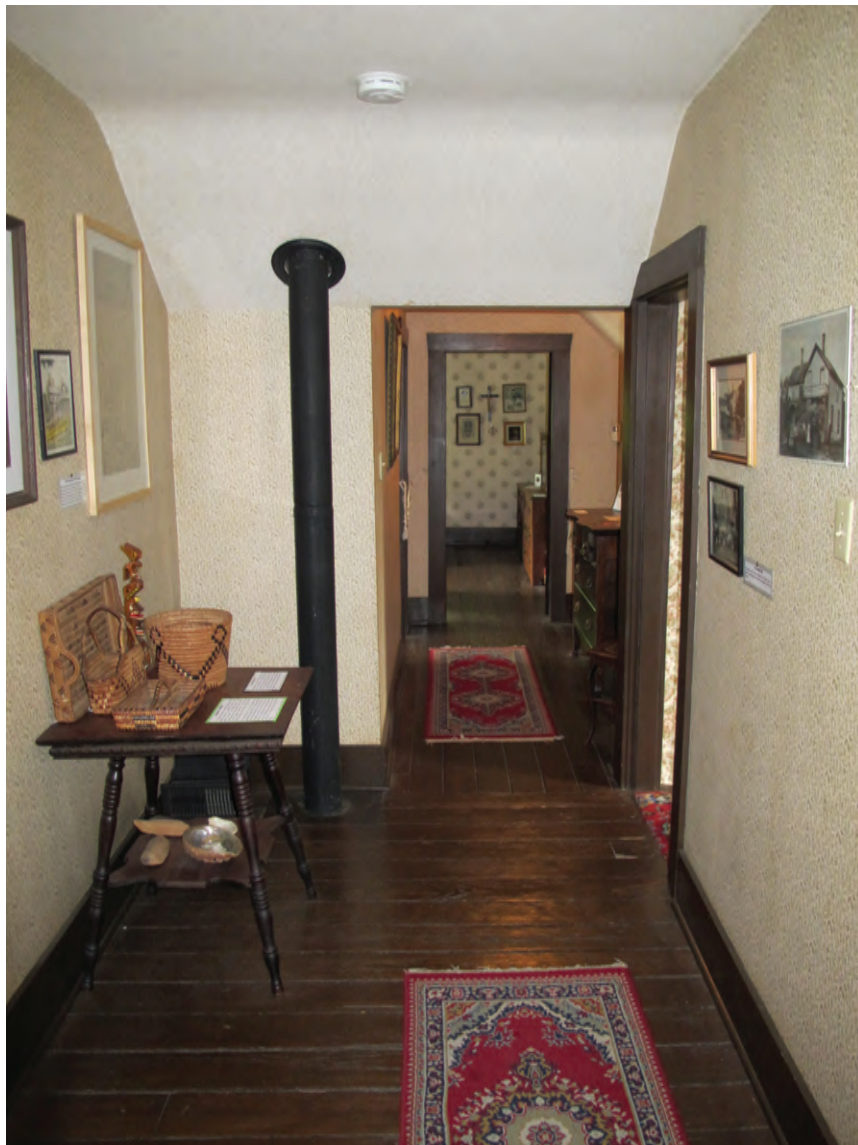
The wooden floor is 5 ½" wide, hand-planed fir, running in two directions and much of it likely dates from the original 1883 construction. It looks scuffed, but appears to be in reasonable condition. The walls and ceilings were wallpapered in the 1979-80 renovations. The window on the east wall appears to have been shortened from its original height, from the bottom.

Upper Hall

- Restore the upper hall to a decided restoration era.
- Preserve and restore original wood elements based on the recommendations in Section 6.1.1.
- Preserve the bullet holes in the floor, as well as indications of original staircase location.
- Preserve any original furnishings in the upper hall, and continue to display the room with appropriate artifacts and as an accurate example of the restoration era.
- The existing wallpaper is not appropriate to the historic character of the house, and should be replaced with another, appropriate wallpaper.

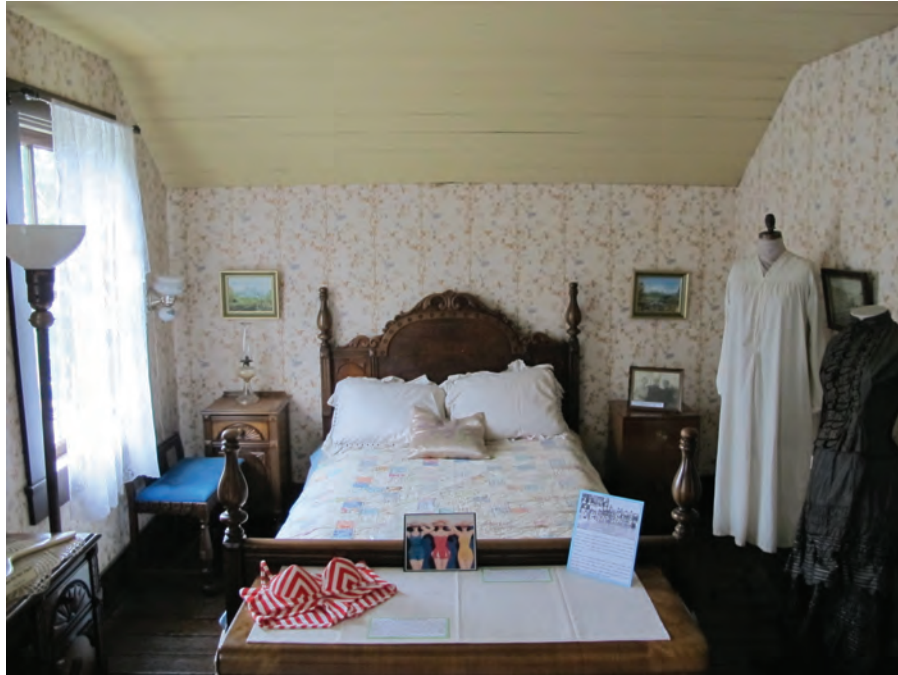
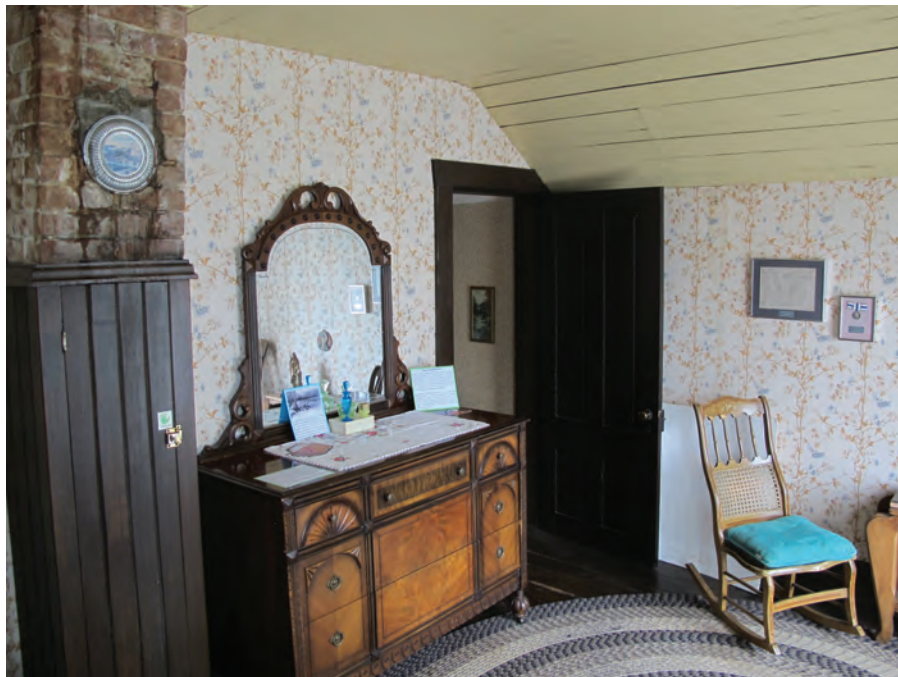
Interior of Master Bedroom

- Restore the master bedroom to a decided restoration era.
- Preserve and restore original wood elements based on the recommendations in Section 6.1.1.
- Preserve any original furnishings in the master bedroom, and continue to display the room with appropriate artifacts and as an accurate example of the restoration era.
- The existing wallpaper is not appropriate to the historic character of the house, and should be replaced with another, appropriate wallpaper.

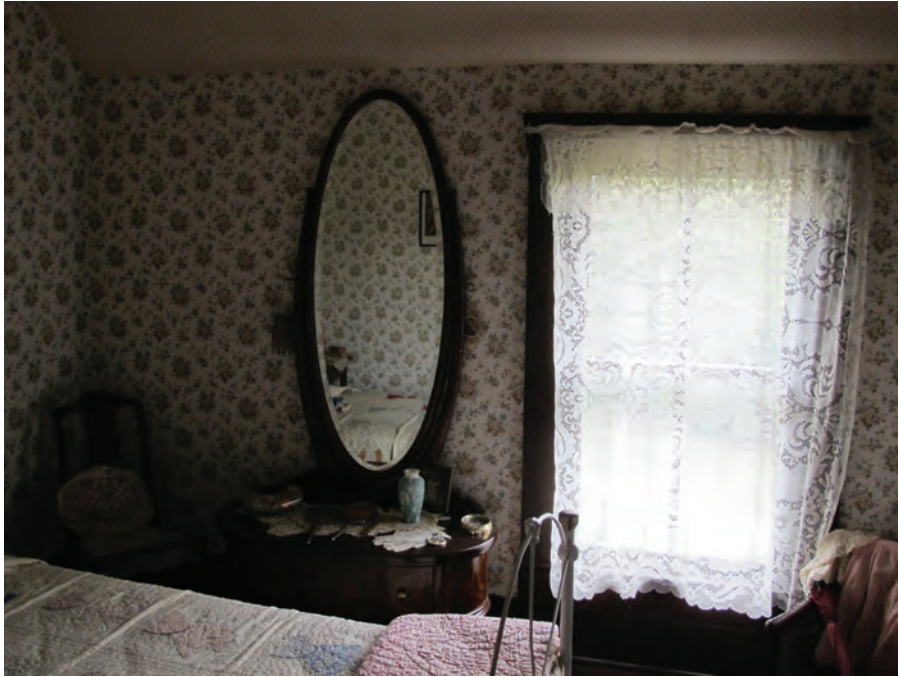
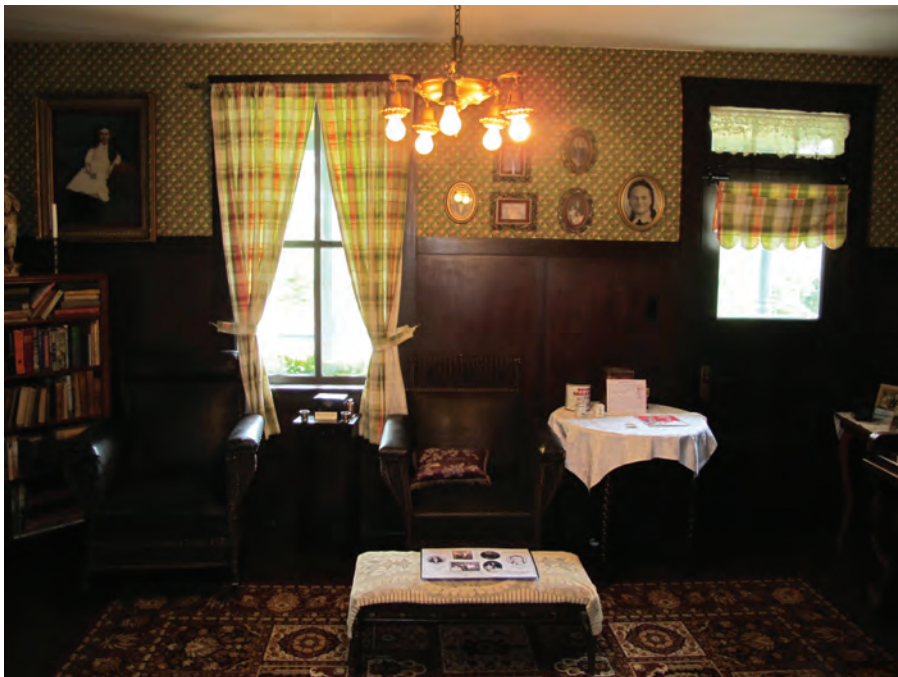
Girl's Room

- Restore the girl's room to a decided restoration era.
- Preserve and restore original wood elements based on the recommendations in Section 6.1.1.
- Preserve any original furnishings in the room, and continue to display the room with appropriate artifacts and as an accurate example of the restoration era.
- The existing wallpaper is not appropriate to the historic character of the house, and should be replaced with another, appropriate wallpaper.

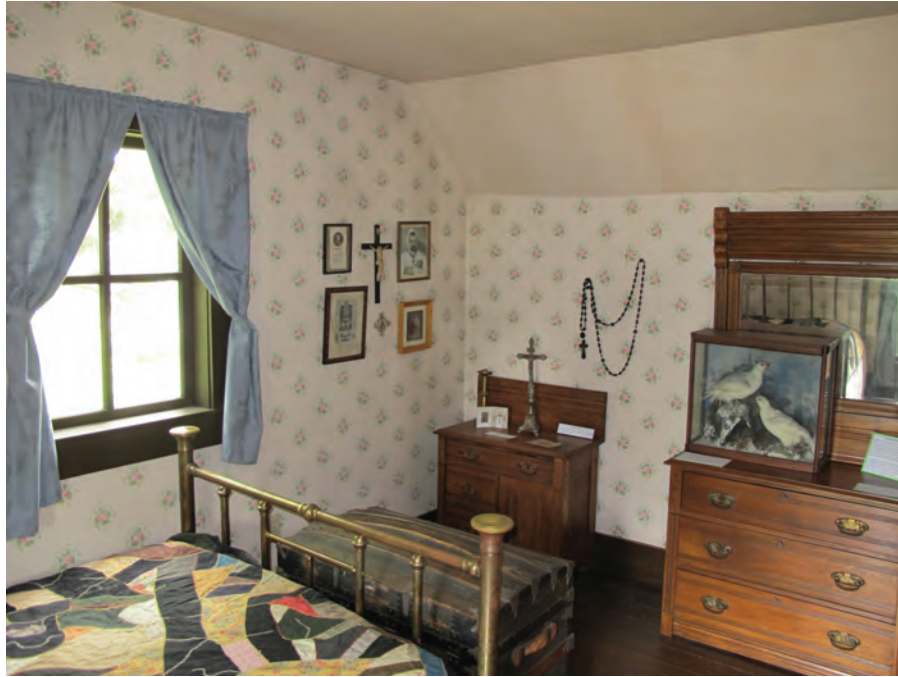
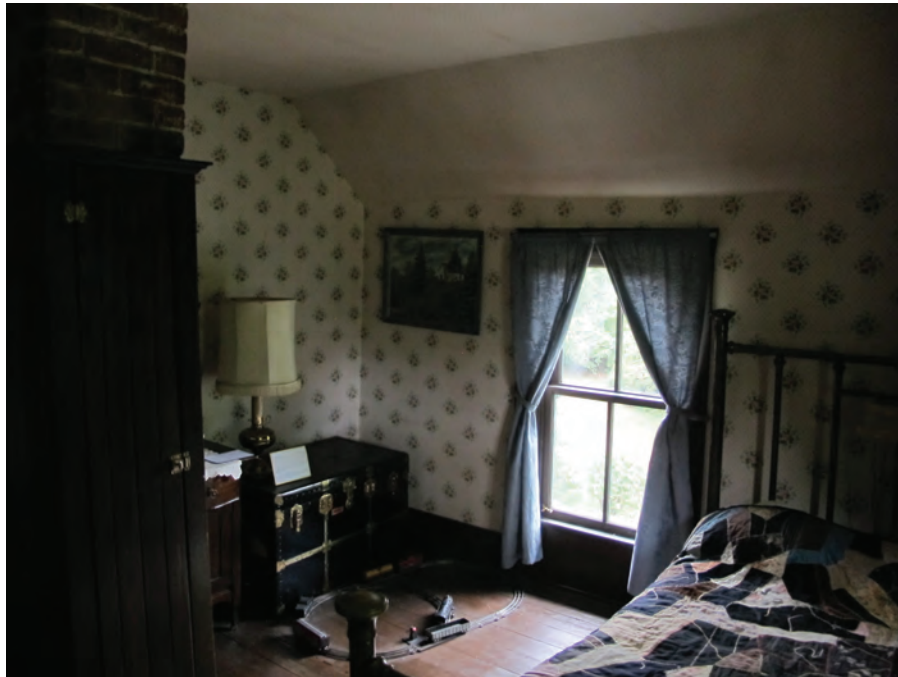
Boys / Priest's Room

- Restore the boys / priest's room to a decided restoration era.
- Preserve and restore original wood elements based on the recommendations in Section 6.1.1.
- Preserve any original furnishings in the boys / priest's room, and continue to display the room with appropriate artifacts and as an accurate example of the restoration era.
- The existing wallpaper is not appropriate to the historic character of the house, and should be replaced with another, appropriate wallpaper.
