City of Maple Ridge Whonnock Well Water Quality Report 2017

WHONNOCK WELL WATER QUALITY REPORT 2017

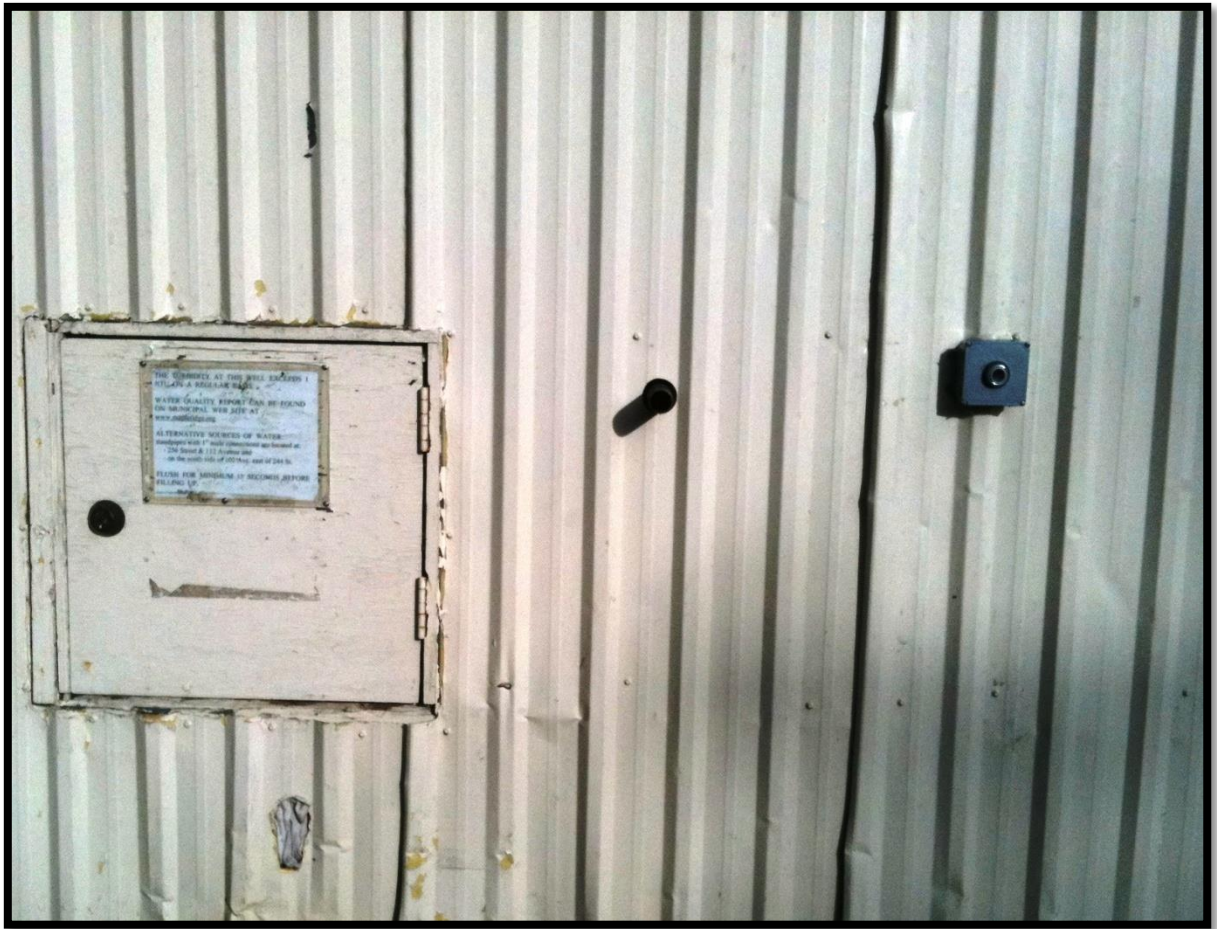
Outside Tap and Push Button
